**ON'S BELL
NEWS ON
THE WAY!**

Date:
30/04/2025
Number: 163

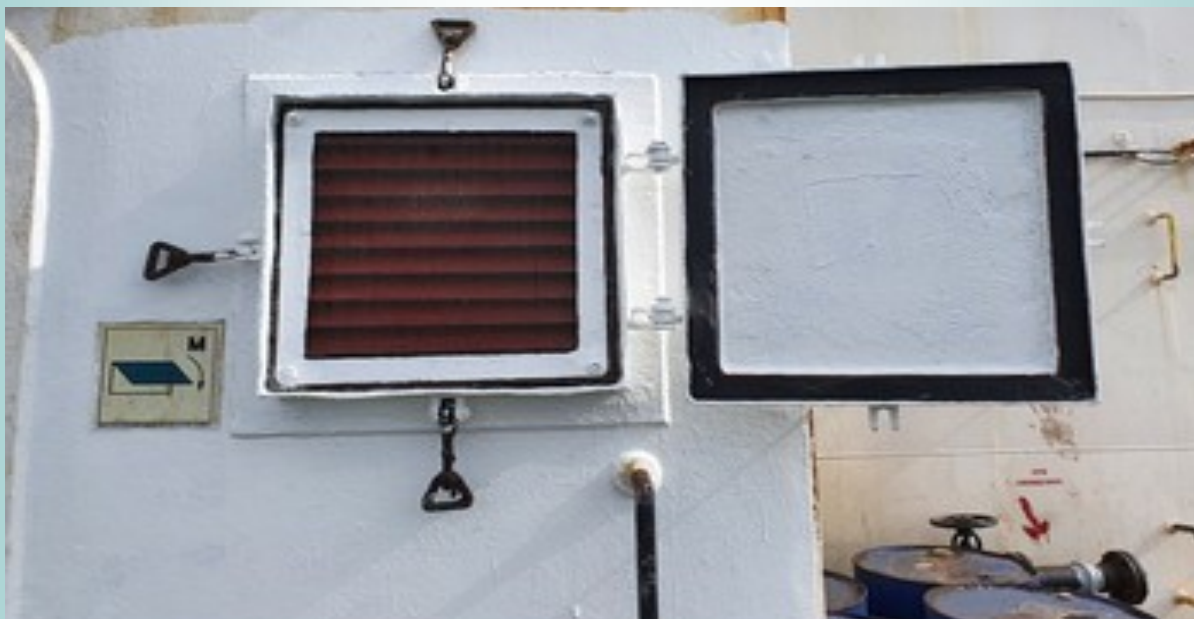
Upon completion of scheduled work on the main deck, the Officer of the Watch (OOW) on the bridge observed that the ventilation flaps at the forward station had been left open. These flaps were not secured following the conclusion of deck operations.

Had this gone unnoticed in the event of bad weather or heavy seas, seawater could have entered the forward compartment. This would have posed serious risks, including potential flooding, damage to electrical panels, and adverse effects on the ship's stability due to water ingress in a low and forward space.

Reinforce post-job inspection routines, including flap/hatch checks

Incorporate ventilation flap status into standard work completion checklist

Conduct crew training on the importance of securing openings

Improve bridge-deck communication regarding critical safety items during and after operations

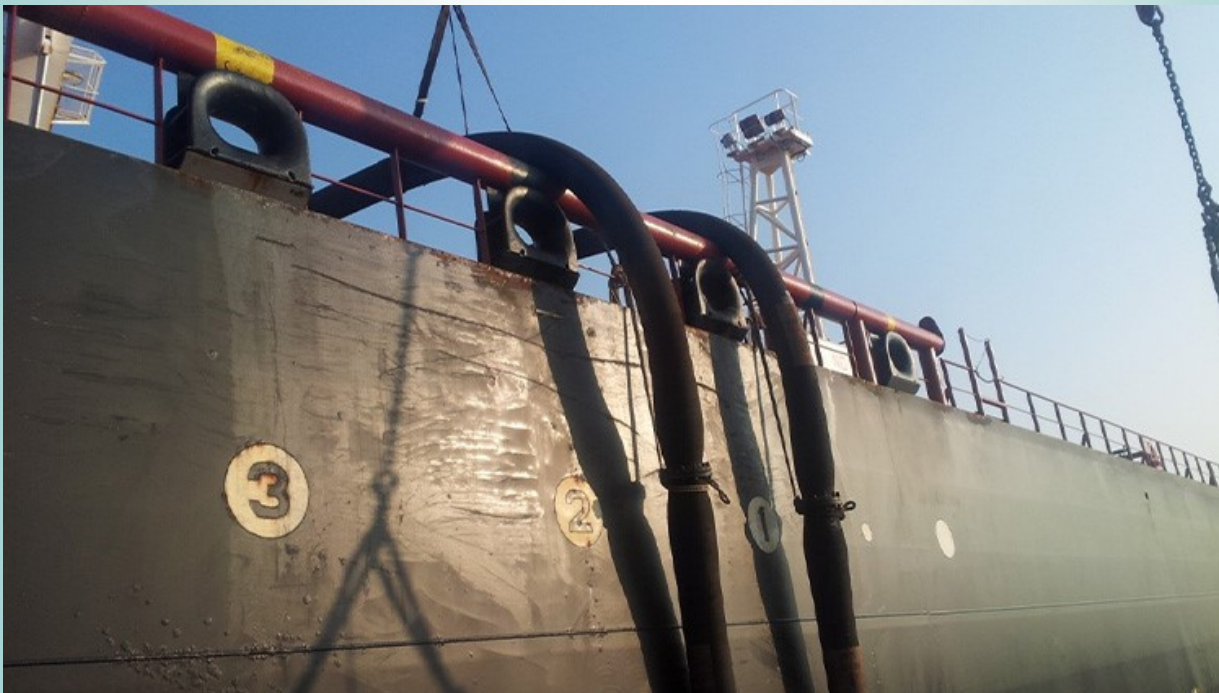
During loading preparations, the pumpman identified that the cargo hose was not properly tightened to the ship's manifold. The issue was discovered before the commencement of cargo operations, as a result of the double-check process required by the vessel's pre-loading checklist.

A pressure test was subsequently carried out, confirming the integrity of the connection, and the cargo loading operation commenced without further issue.

Inadequate attention during initial hose connection.

Failure to properly follow connection verification procedures at the first step.
